Practical Experiences of Biofouling in Reverse Osmosis Systems

By L. Y. Dudley and N. S. J. Christopher, PermaCare®

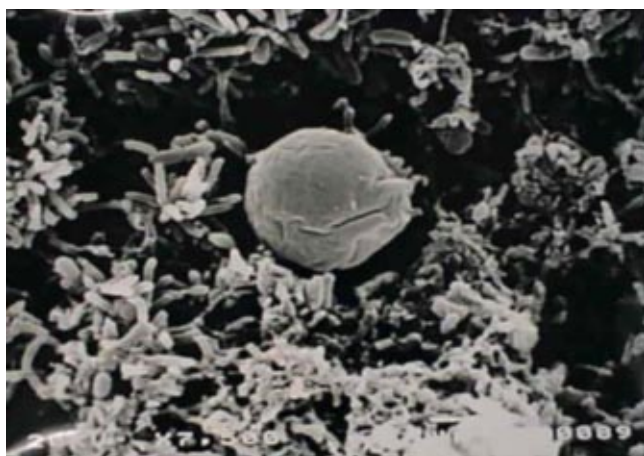
On inspection, the membrane layers appeared moist and uniformly covered with foulant. A fawn-coloured deposit was visible on the leaves but not on the plastic spacer material.

The foulant contained 96% moisture. Chemical analysis of the dried deposit identified organics (76%), silica (7%), calcium as calcium phosphate (4%), calcium as calcium sulphate (3%) and iron as iron oxide (3%) as the major foulants. Humic acid determinations found the organic composition to be 44% humic substances.

Microbiological analysis of the fouled membrane showed 2.88×10^6 cfu/cm² of bacteria present on the surface with 1.81×10^5 cfu/cm² on the plastic spacer material. No fungi or yeasts were isolated, but significant numbers of bacteria were identified on the product water carrier.

Only one genus of bacteria was identified as predominating on the membrane surface; this is unusual in biofouled systems. The organisms detected were *Pseudomonas vesicularis* and *Pseudomonas fluorescens*. *Pseudomonas* is recognised as a prolific slime producer, often predominating in water systems.

Figure 3 — SEM of biofouled membrane. Magnification x7,500.

SEM micrographs clearly showed the presence of large quantities of biofilm material but relatively small numbers of bacteria on the fouled membranes (Figure 3). This biofilm had unusual characteristics. Although the pressure drop across the system had greatly increased, the membrane flux was not significantly affected. This indicated that the biofilm had properties that affected the hydraulic resistance and drag resistance of the feedwater flow but did not affect the porosity of the membranes.

This biofilm was particularly difficult to remove using standard cleaning procedures. The only success in removing the foulant was with a surfactant clean at pH 13, which exceeds the normally advised pH limits stated by the membrane manufacturers.
