Practical Experiences of Biofouling in Reverse Osmosis Systems

By L. Y. Dudley and N. S. J. Christopher, PermaCare®

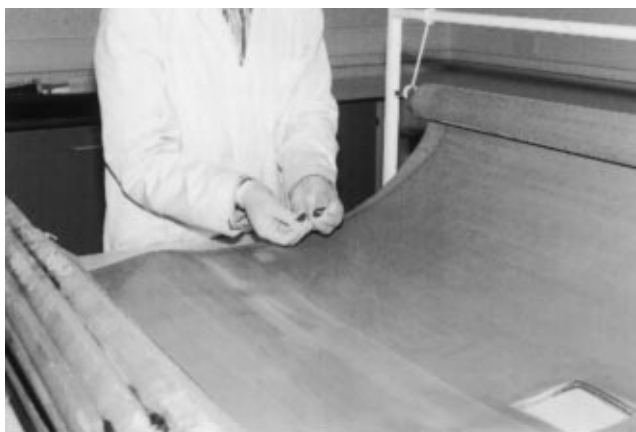
Figure 2 — Membrane autopsy

sample is then scraped from a known surface area for microbiological and chemical analysis (Figure 2). Results of these analyses can then be expressed in terms of foulant composition and colony forming units (cfu) per cm² of membrane area.
